Manhole Inspection Summary

Manhole # S17S__011MH

Insp Date: **5/6/09 1:56 PM**

Location Address: **1500 CARROLL PARK**

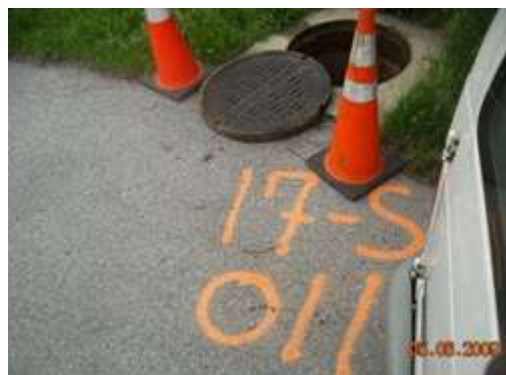
Miscellaneous

PAVEMENT MARKED

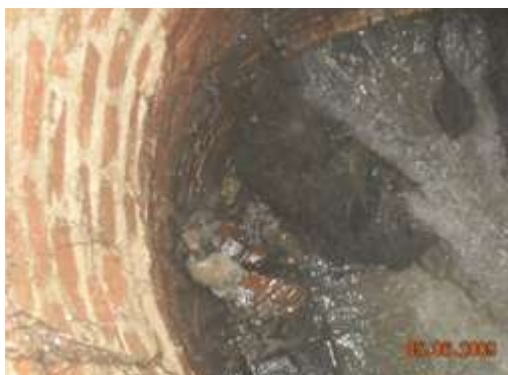
Defect 5

Condition: ☐ Sound ☐ Cracked ☐ Root Intrusion ☐ Deteriorated ☐ Leaks ☒ **Debris**

DEBRIS ON BENCH

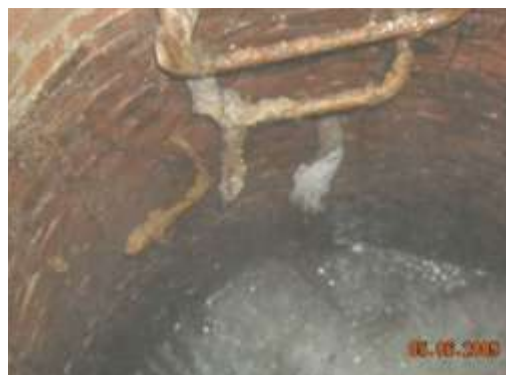
Defect 4

☒ **Evidence Of Surcharge**

Depth: **6** (ft.) ☐ Active Surcharge Present

EVIDENCE OF SURCHARGE

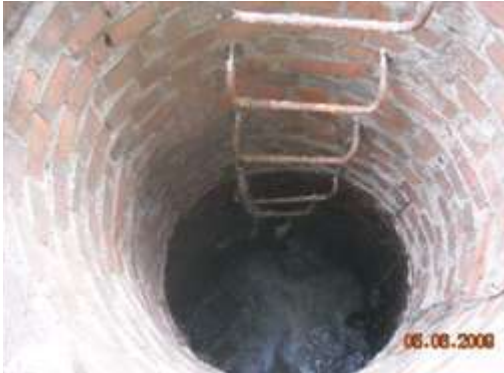
Defect 3

Count: **5** Missing: **5** ☒ **Corroded**

CORRODED & MISSING STEPS

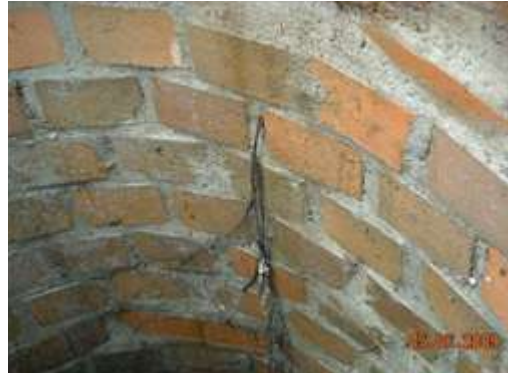
Defect 2

Condition: ☐ Sound ☐ Cracked ☒ **Root Intrusion** ☐ Loose Brick ☐ Deteriorated

Infiltration: ☐ None ☐ Joint ☐ Cracks ☐ Mortar ☒ **Roots** ☐ Wall

ROOT INTRUSION @ CORBEL WALL

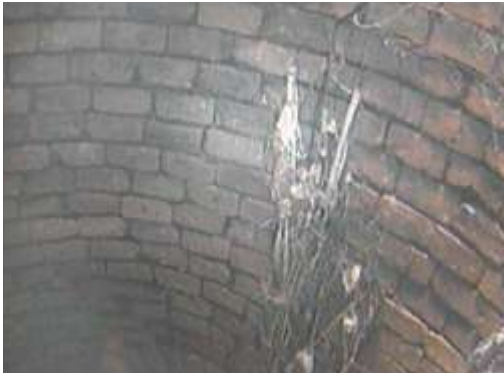
Defect 1

Condition: ☐ Sound ☐ Cracked ☒ **Root Intrusion** ☐ Loose Brick ☐ Deteriorated

Infiltration: ☐ None ☐ Joint ☐ Cracks ☐ Mortar ☒ **Roots** ☐ Wall

ROOT INTRUSION @ BARREL WALL

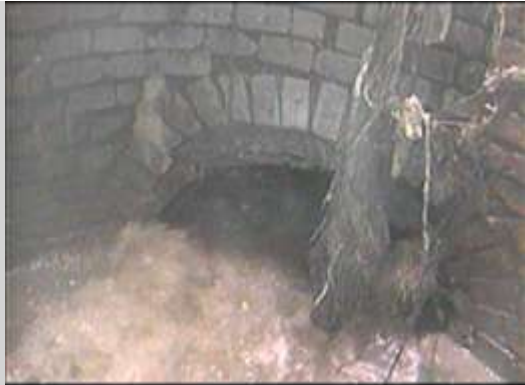
12 O'Clock Outflow

27 in. Circular Gravity Sewer
Pipe Out @ 12 O'Clock

Pipe Height: **27.6** (in.) Rod and Bar (Angled)
Pipe Material: **Clay** ☐ Pipe Lined
Invert Depth: **15.20** (ft.) Flow Characteristics: **Turbulent**
Deposits: ☒ None ☐ Mud ☐ Sludge ☐ Debris ☐ Grease
Silt Depth: **0** (in.) Deposits Extent:
Infiltration: **None** Pipe Seal Cond: **Roots**

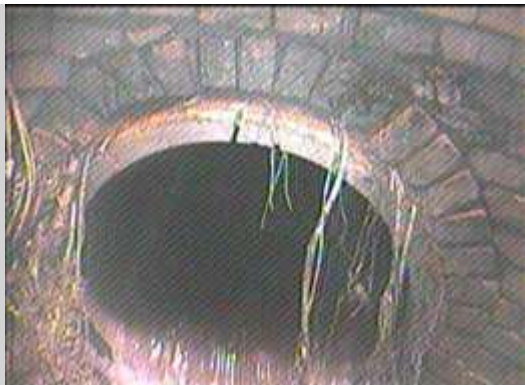
5 O'Clock Inflow

24 in. Circular Gravity Sewer
Pipe In @ 5 O'Clock

Pipe Height: **24** (in.) Rod and Bar (Angled)
Pipe Material: **Clay** ☐ Pipe Lined
Invert Depth: **13.00** (ft.) Flow Characteristics: **Turbulent**
Deposits: ☒ None ☐ Mud ☐ Sludge ☐ Debris ☐ Grease
Silt Depth: **0** (in.) Deposits Extent:
Infiltration: **Weeper** Pipe Seal Cond: **Broken**

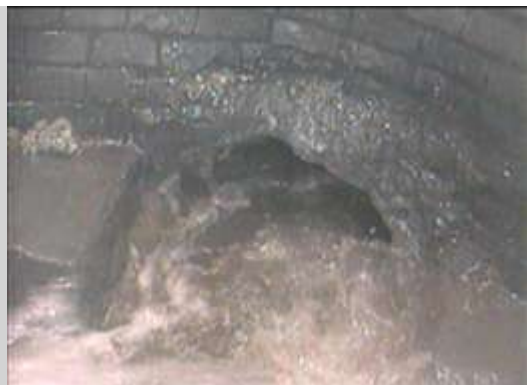
8 O'Clock Inflow

24 in. Circular Gravity Sewer
Pipe In @ 8 O'Clock

Infiltration: **Evidence**

Pipe Seal Cond: **Unknown**
